International Conference on Space Optics—ICSO 2012

ESCC standards, evaluation and qualification of optical fiber connectors for space application

Frederic Taugwalder
Diamond SA Losone, Switzerland
frederic.taugwalder@diamond-fo.com

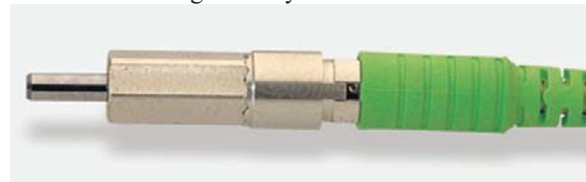
fig. 1 AVIM with WC ferrule

The AVIM connector, a special version of our original AVIO (for avionics), was designed with an hexagonal nut for Lockheed Martin [2] (Martin Marietta, hence the M on AVIM). The connector was qualified by Rifocs, our former distributor and partner in US and Lockheed Martin in the mid 90's. The AVIM version qualified at the time had a bi-component ferrule made of a tungsten carbide (WC) sleeve and a glued Nickel Silver insert. It has flown extensively on airplanes and on few other mission for NASA: GLAS[1,2,5] on ICESAT and on MLA[1]. The latter represents the Diamond connector closest to the sun and orbiting Mercury since the end of 2011.

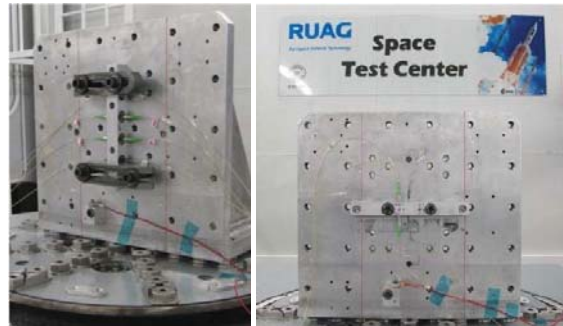
fig. 9 Vibration table at Ruag Space

The vibration results were very interesting. An AVIM adapter fixing screw broke at 75grms causing the adapter to brake at 90grms. We replaced the adapter with an hexagonal flange version and repeated the tests without problems. For the Mini-AVIM, nothing happened and the results were excellent up to 90grms.

6.4.5	Random vibration	2	IEC 60068-2-64	25grms, 50grms, 75grms, 90grms 20Hz to 2000Hz 7.5min per axis	Adapter screw broke at 75g inducing ferrule damage. Test reformed with hexagonal adapter (no screws), performed up to 90grms (IL, RL and ER) with IL variation at 75g. Visual damages of interface. Damages appearing at 50grms. Sent 6.4.14	Optically functioning up to 90grms (IL variation 0.1dBmax), but visual damages of interface. Damages appearing at 75grms. Sent to 6.4.14

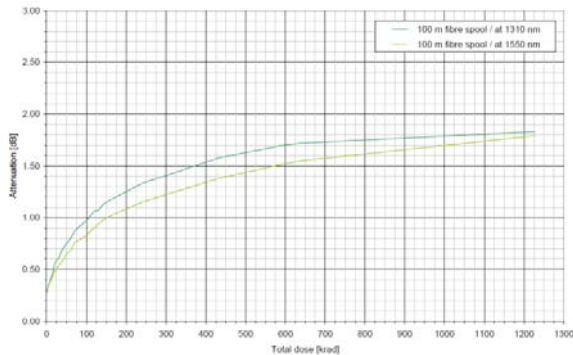
fig. 12 Insertion loss on 100m fiber spool at 25°C for Fujikura SM.15-P-8/125-UV/UV-400. Dose rate of 8.14krad/h, 23.8°C, 34.8%r.h., 1019mbar

During the radiation tests performed at ESTEC, no radiation impact was observed on the connectors, but a clear impact was seen on the PM fiber. The following graph shows the absorption versus irradiation as measured during the exposure.

6.4.10	Radiation	4	ESCC 22900	⁶⁰ Co, 1180 krad total, 8.14 krad/h, ambient	No problem observed on connector. Fiber with logarithmic absorption curve	No problem observed on connector. Fiber with logarithmic absorption curve

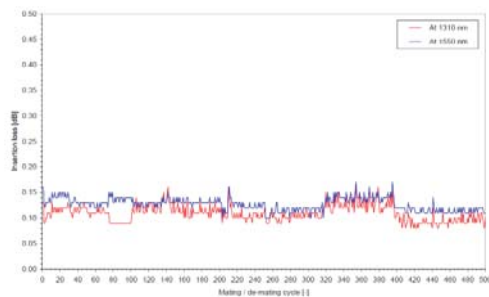
fig. 14 Reproducibility of the Mini-AVIM

The Mini-AVIM did not suffer even after 500 cycles, showing the positive effect of using titanium on titanium.
